Manhole Inspection Summary

Manhole # S150__026MH

Location Address: **2802 frederick av**

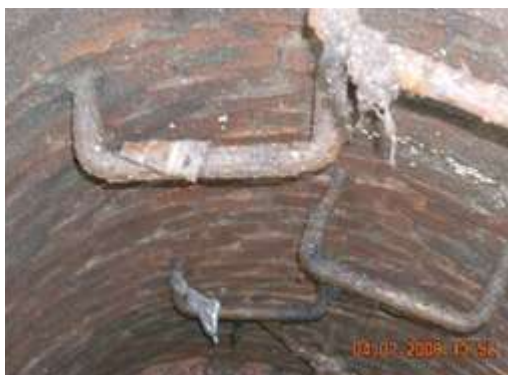
Defect 2

Infiltration: ☐ None ☒ **Joint** ☐ Cracks ☐ Mortar ☐ Roots ☐ Wall

Surcharge ☒ **Evidence Of Surcharge** Depth: **6** (ft.) ☐ Active Surcharge Present

surcharge and corbel flow joint evidence

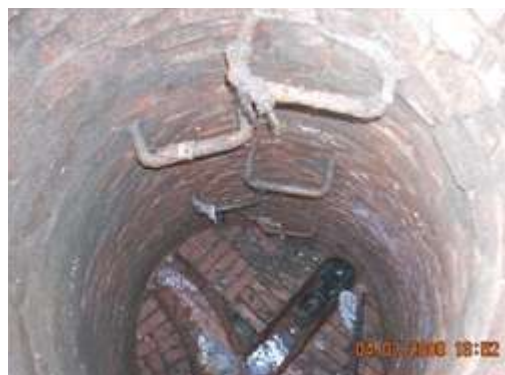
Defect 1

Steps Count: **5** Missing: **0** ☒ **Corroded**

corroded steps

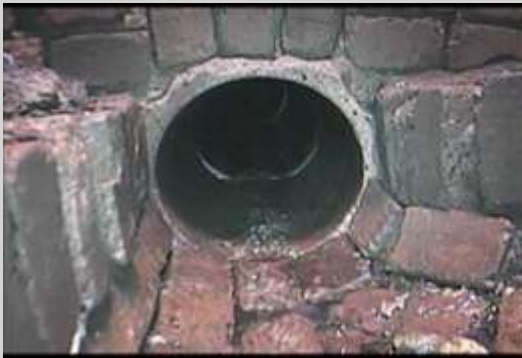
12 O'Clock Outflow

8 in. Circular Gravity Sewer
Pipe Out @ 12 O'Clock

Pipe Height: **8.4** (in.) Rod and Bar (Angled)
Pipe Material: **Clay** ☐ Pipe Lined
Invert Depth: **9.58** (ft.) Flow Characteristics: **Slow**
Deposits: ☒ None ☐ Mud ☐ Gravy ☐ Debris ☐ Grease
Silt Depth: **0** (in.) Deposits Extent:
Infiltration: **None** Pipe Seal Cond: **Sound**

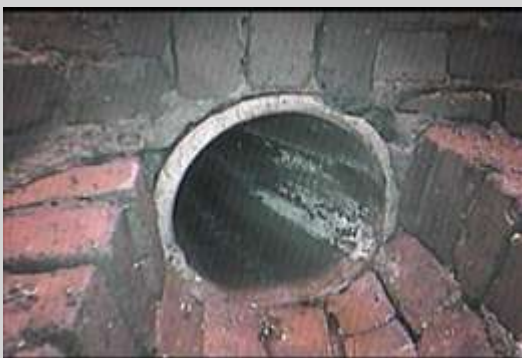
3 O'Clock Inflow

8 in. Circular Gravity Sewer
Pipe In @ 3 O'Clock

Pipe Height: **7.2** (in.) Rod and Bar (Angled)
Pipe Material: **Clay** ☐ Pipe Lined
Invert Depth: **8.99** (ft.) Flow Characteristics: **Slow**
Deposits: ☒ None ☐ Mud ☐ Gravy ☐ Debris ☐ Grease
Silt Depth: **0** (in.) Deposits Extent:
Infiltration: **None** Pipe Seal Cond: **Sound**

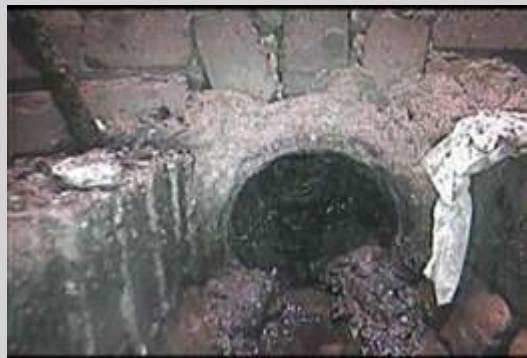
6 O'Clock Inflow

6 in. Circular Gravity Sewer
Pipe In @ 6 O'Clock

Deposits: ☐ None ☒ **Mud** ☒ **Sludge** ☐ Debris ☐ Grease

Silt Depth: **3** (in.) Deposits Extent: **Medium**
